# historic structure report

## restore historic commissary building to 1897

# FORT SMITH

HISTORIC STRUCTURE REPORT  
RESTORE HISTORIC COMMISSARY BUILDING TO 1897

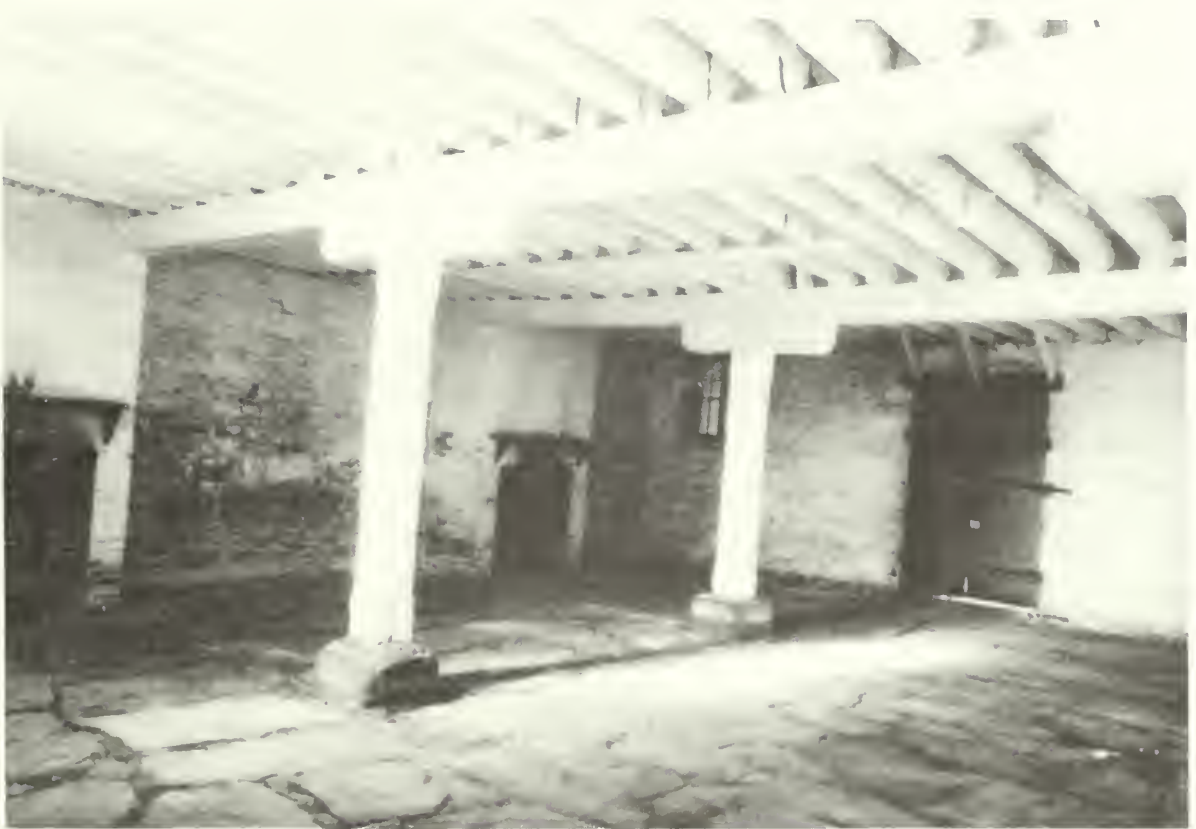
Figure 102. First Floor (1/3/85): Looking at the restored commissary storeroom from the visitor platform, the space is seen as the display. Notice darker pattern on west wall - between fireplaces - that may be a historic ghost, indicating former furnishings. Restoration of the double doors (north entry), including fitting them with an iron crossbar was historic practice. Note, also, that lights, smoke detectors, magnetic intrusion detectors, and associated conduit are imperceptible from the visitor's point of view.

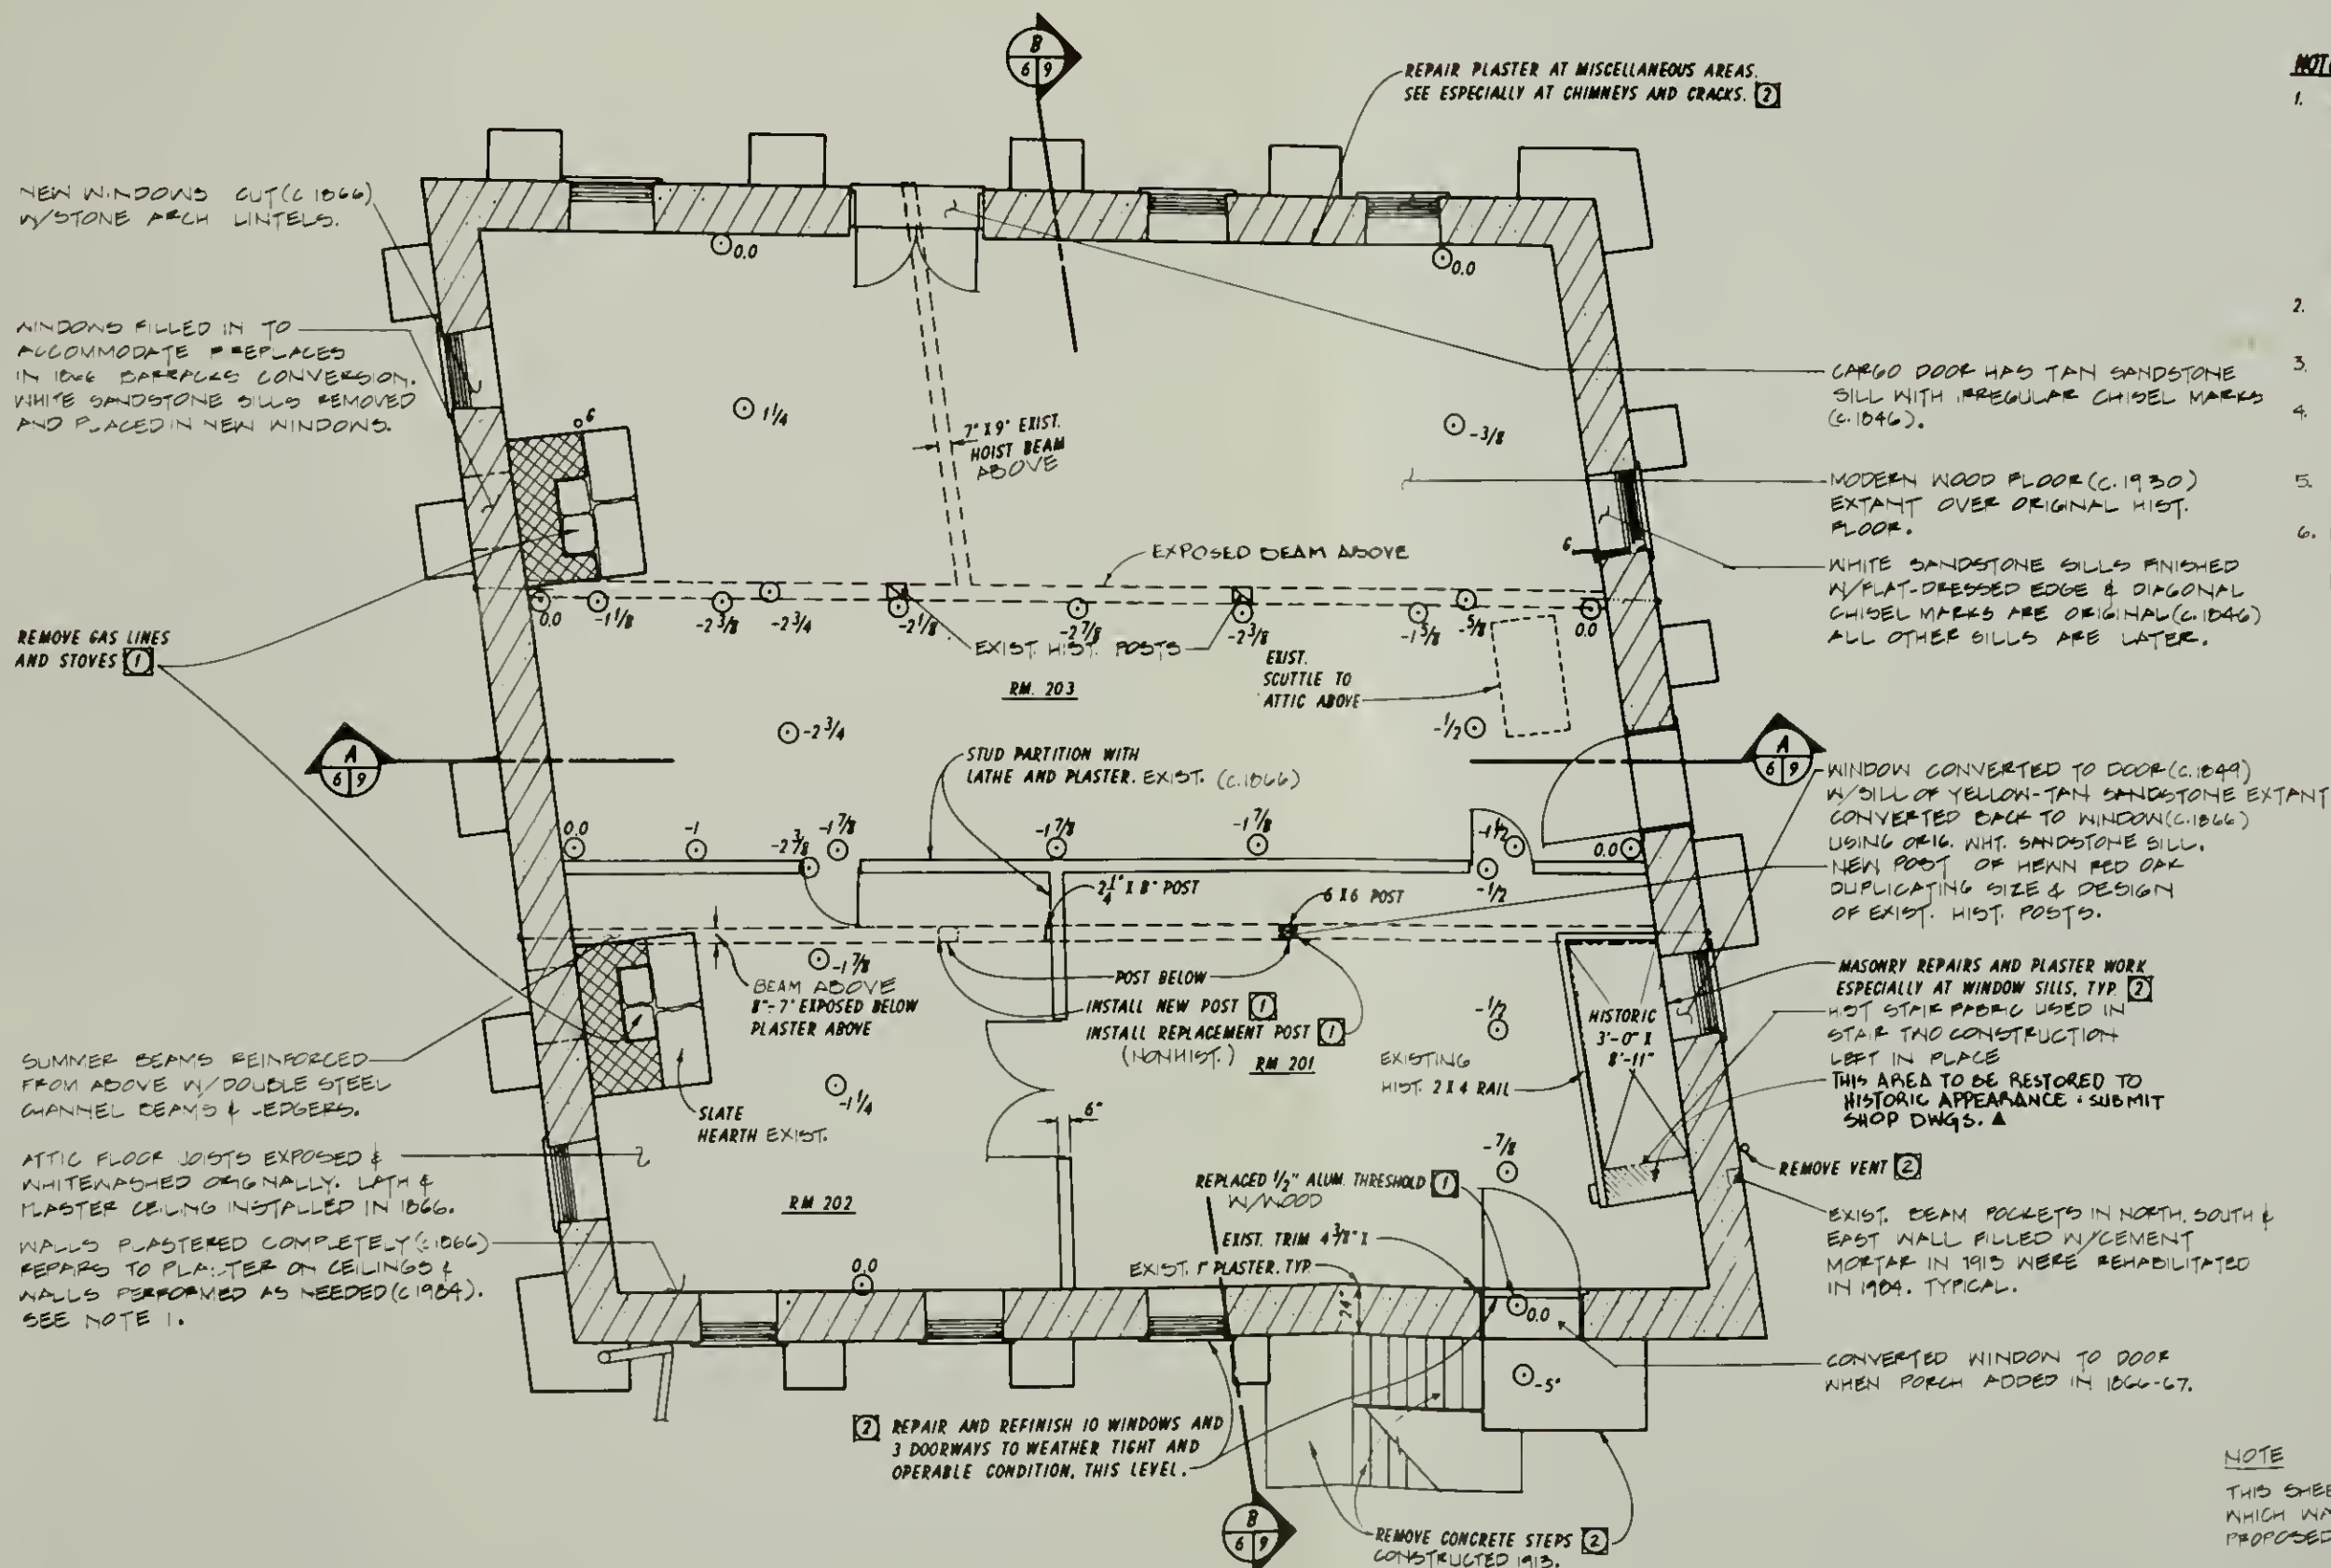
DESIGNED HISTORIC: FRAZIER	SUB SHEET NO.	TITLE OF SHEET	DRAWING NO. 421
DRAWN: C. Dehn		SECOND FLOOR PLAN TREATMENTS	25,001
TECH. REVIEW THORSON		PHASE I & II	PKG. NO. 104
DATE 7/85			SHEET 9
			OF 14

WALLS PLASTERED COMPLETELY.  
REPAIRS TO PLASTER ON CEILING  
WALLS PERFORMED AS NEEDED (C  
SEE NOTE 1).

1. PLASTER MIX DESIGN TO BE BASED ON ANALYSIS OF EXISTING HISTORIC. BASE COAT- SCRATCH DOUBLE-BACK METHOD TO  $< \frac{1}{8}$ " BELOW ADJACENT FINISH PROFILE: 1 PART-ENTRaining VASCONRY CEMENT TYPE I AND 3% HORSEHAIR (12, 1 1/2 lb PER SACK) PLUS 5 PART SCREENED MASONRY SAND. FINISH COAT- 1 GYP GAUGING TO 4 1/4 PART LIME PUTTY (FINISHING HYDRATED LIME TYPE N SLAKED MIN. 12 HR.) TROWEL FINISH TO DUPLICATE ADJACENT TEXTURE PHOTO DOCUMENT BEFORE & AFTER AT EACH LOCATION TREATED.

2. NEW AND REPLACEMENT POSTS, THIS FLOOR, TO MATCH EXISTING SIZE, DESIGN AND CONNECTION DETAILS (OAK).
3. AFTER FIRST FLOOR & EXTERIOR STAIRS ARE REMOVED ACCESS TO SECOND FL. WILL BE BY LADDER.

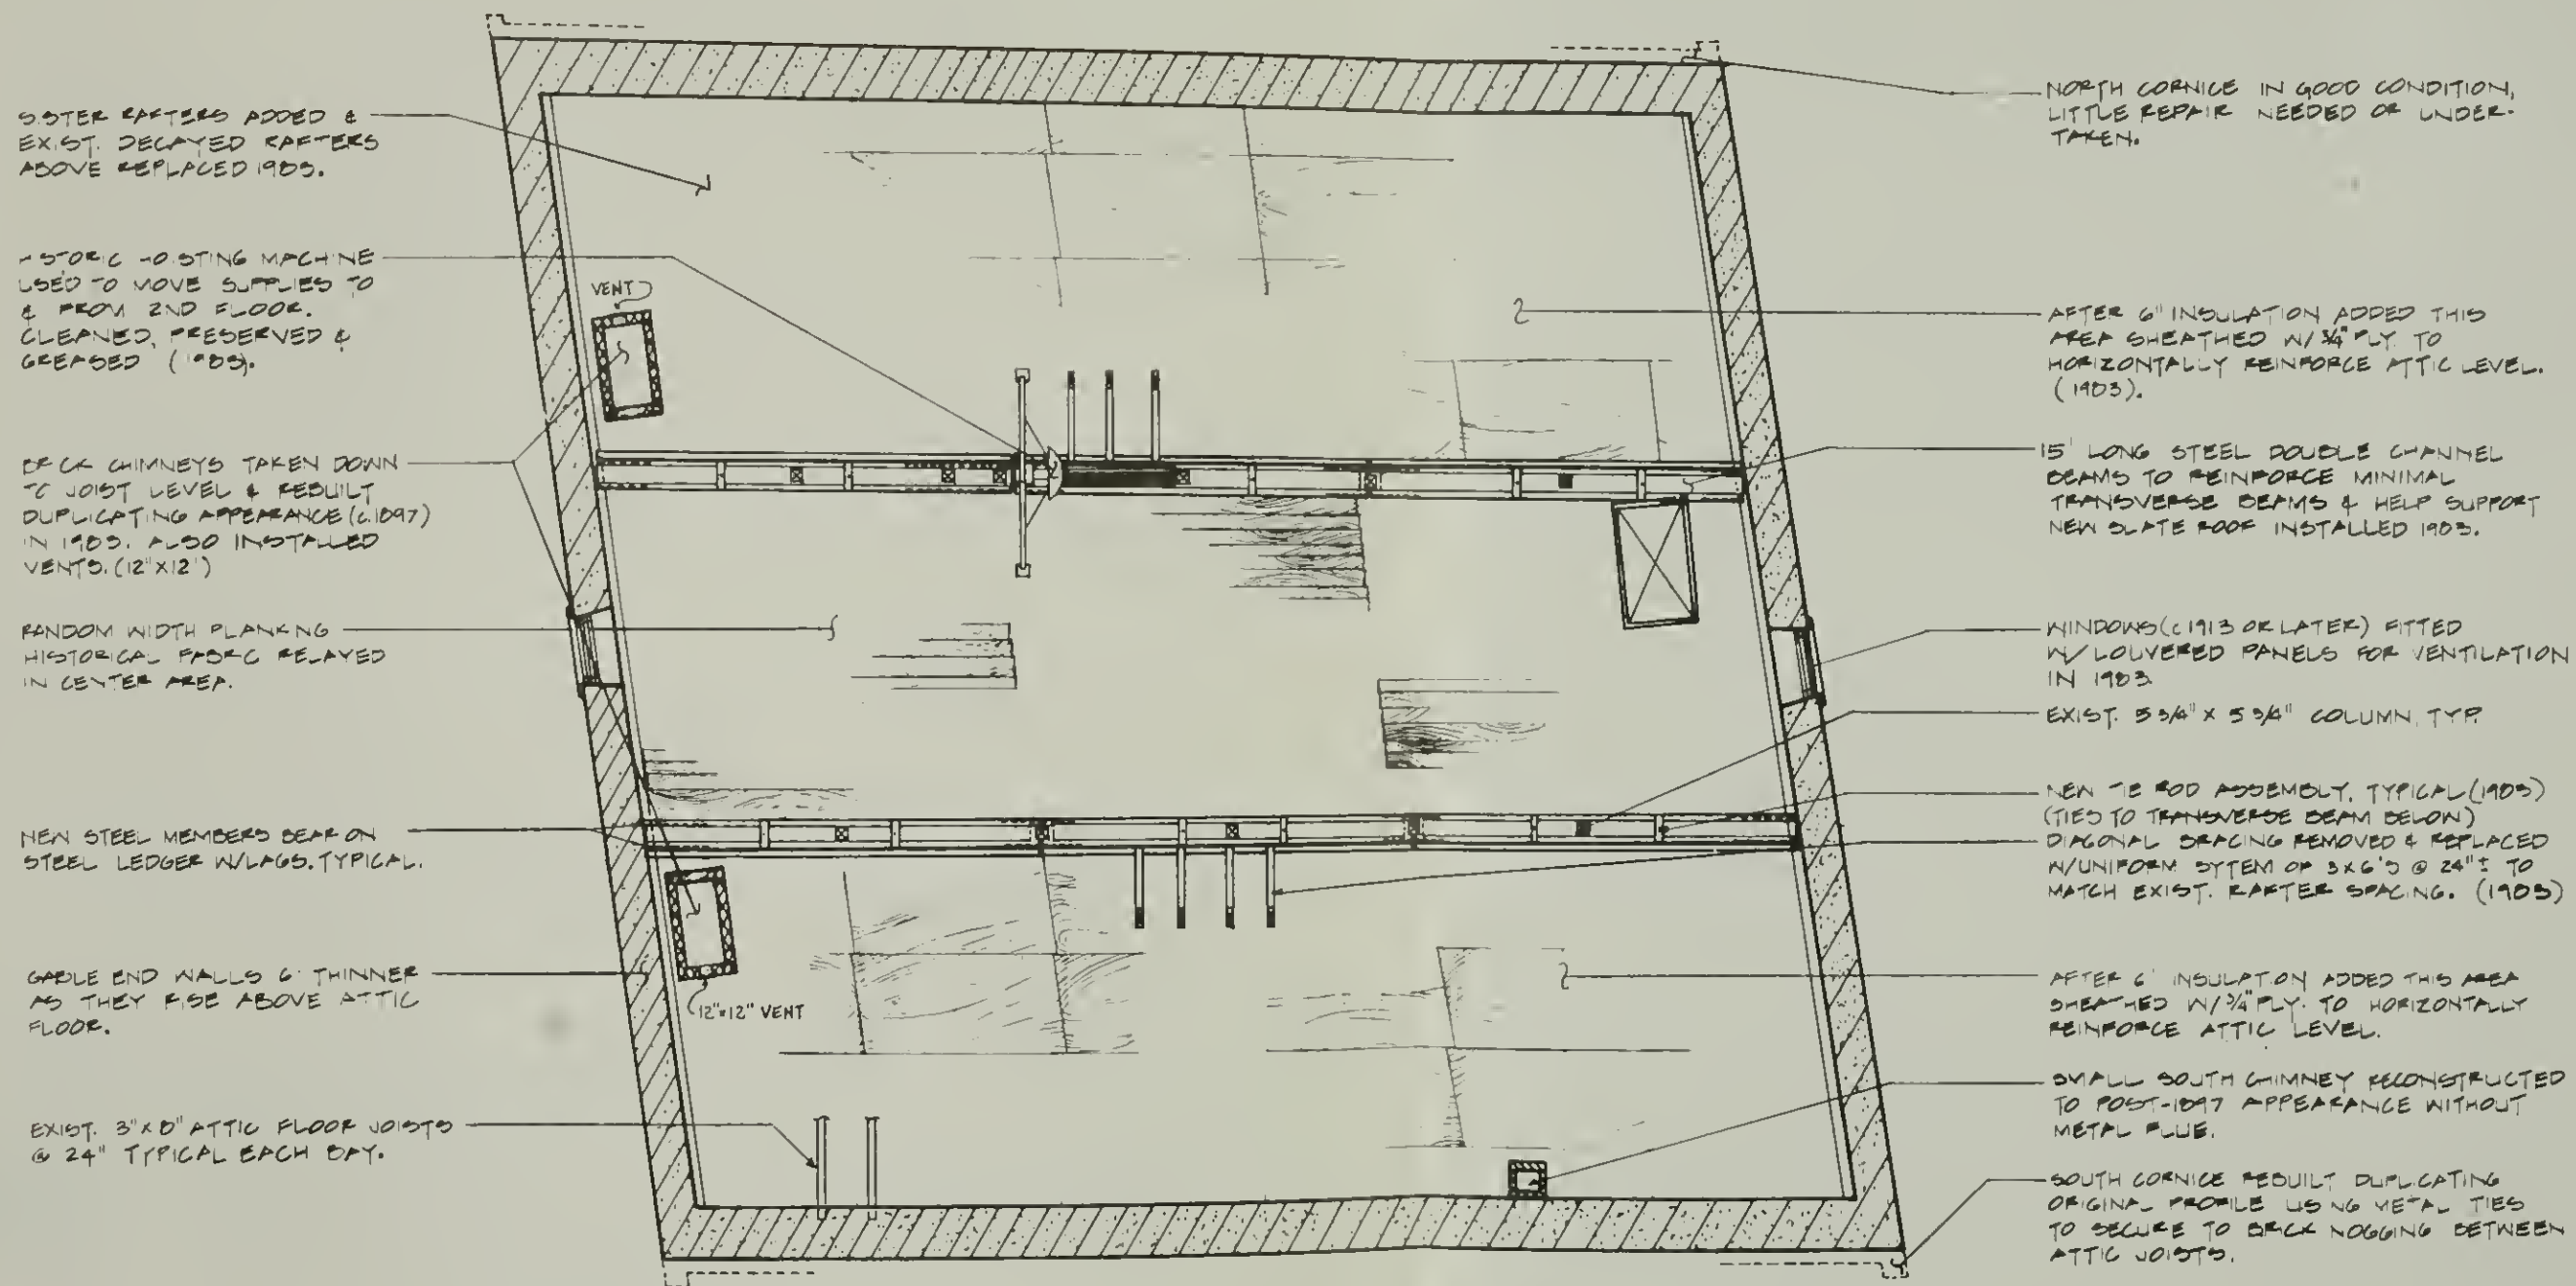
DESIGNED: FRAZIER	SUB SHEET NO.	TITLE OF SHEET	DRAWING NO. 421
DRAWN: WAHBEH		ATTIC FLOOR PLAN	25,001
TECH. REVIEW: THORSON		AFTER TREATMENT	PKG. NO. 104
DATE: 7/85			SHEET 12
			OF 14

SISTER RAFTERS ADDED & EXIST DECAYED RAFTERS ABOVE REPLACED 90S.

- NO VISITOR ACCESS TO ATTIC AREA.
- PLAN CUT BEGINS AT EAVE LEVEL ON NORTH & SOUTH SIDES AND RISES TO WINDOW LEVEL IN CENTER.

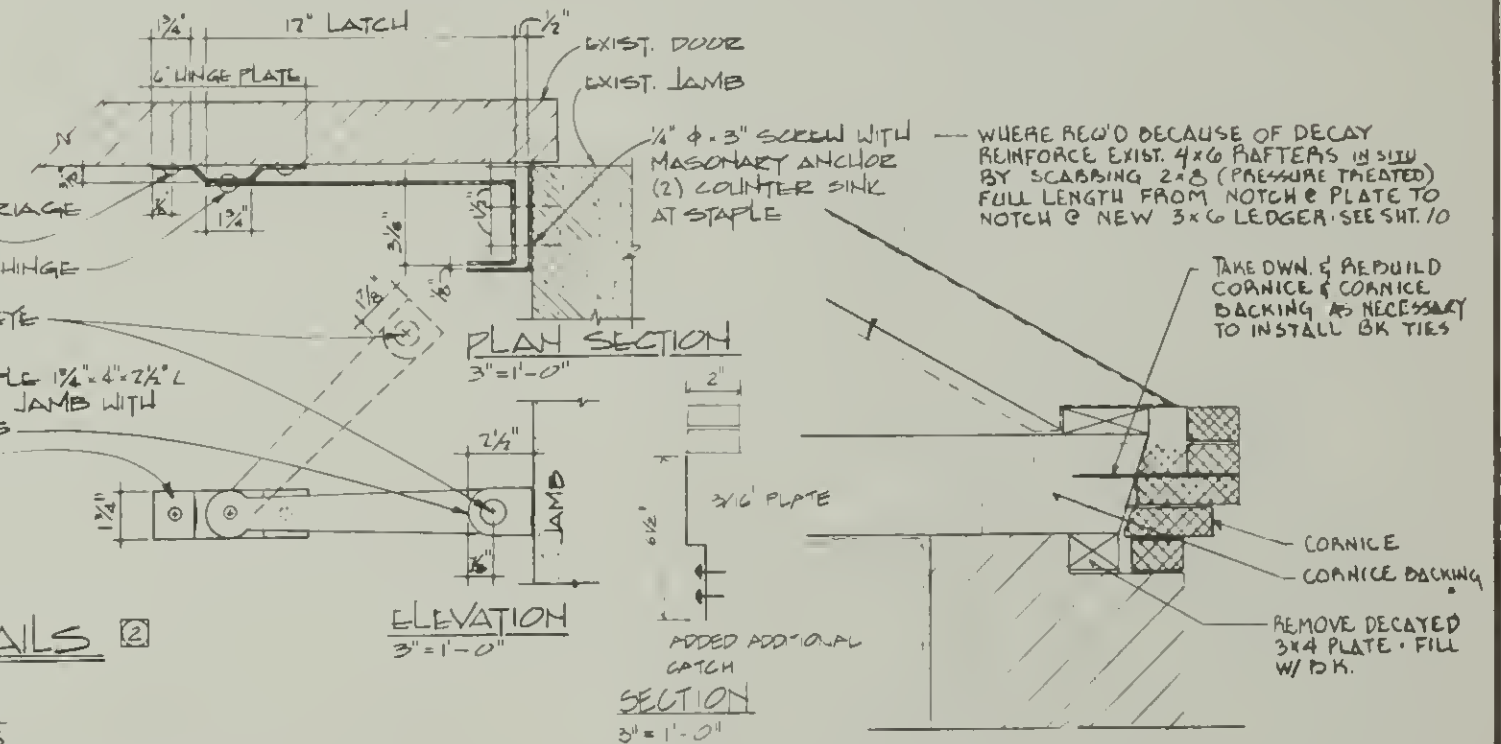
5 SECT. DTL @ CORNICE 1  
1 1/2" = 1'-0"

1. Inspection of the commissary work underway revealed the cornice on the south side had separated and was on the verge of falling off. It was observed that the differential settlement which occurred at the southeast corner had probably caused the cornice failure. Also, the historically weak and presently deteriorated brick masonry mortar was inadequate in its structural role of tying the cornice to its masonry backing. It was recommended that the cornice be taken down to stone level and rebuilt along with its backing - brick ties being installed - to secure the cornice system.
2. The rafter tails presently exposed at the eave plate were observed to have more deterioration than previously known. After discussing alternatives, it was recommended that pressure-treated 2x8 sister-rafters be scabbed to the original, from plate to new ledger, to reinforce the rafters.

WHERE REQ'D BECAUSE OF DECAY  
REINFORCE EXIST. 4x6 RAFTERS IN SILL  
BY SCABBING 2x8 (PRESSURE TREATED)  
FULL LENGTH FROM NOTCH & PLATE TO  
NOTCH & NEW 3x6 LEDGER. SEE SHT. 10
